# Incident Analysis

## MEGA-WAREHOUSE FIRE

9590 Allpoints Parkway | Plainfield, Indiana

**MARCH 15, 2022**

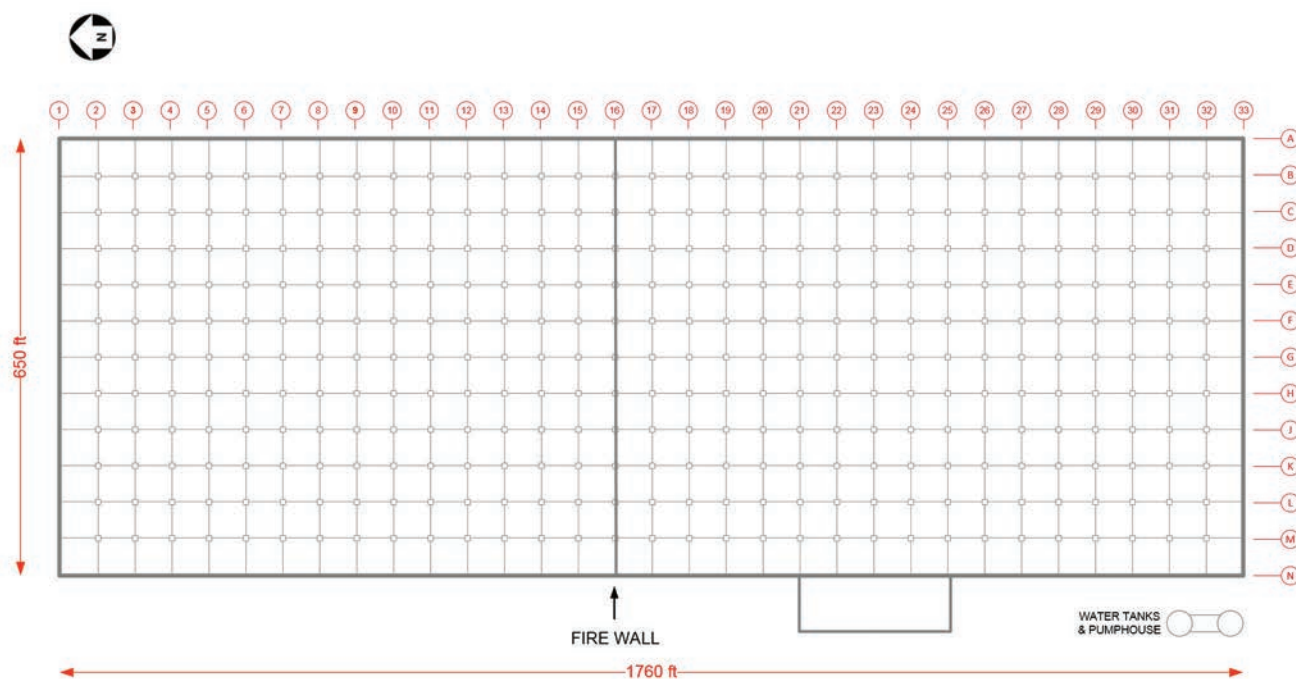
**Figure 3:** The roof was supported by unprotected steel trusses and columns that were arranged in a grid. Each grid square represents 2,862 ft<sup>2</sup>, measuring 54' in the east/west direction X 53' in the north/south direction.

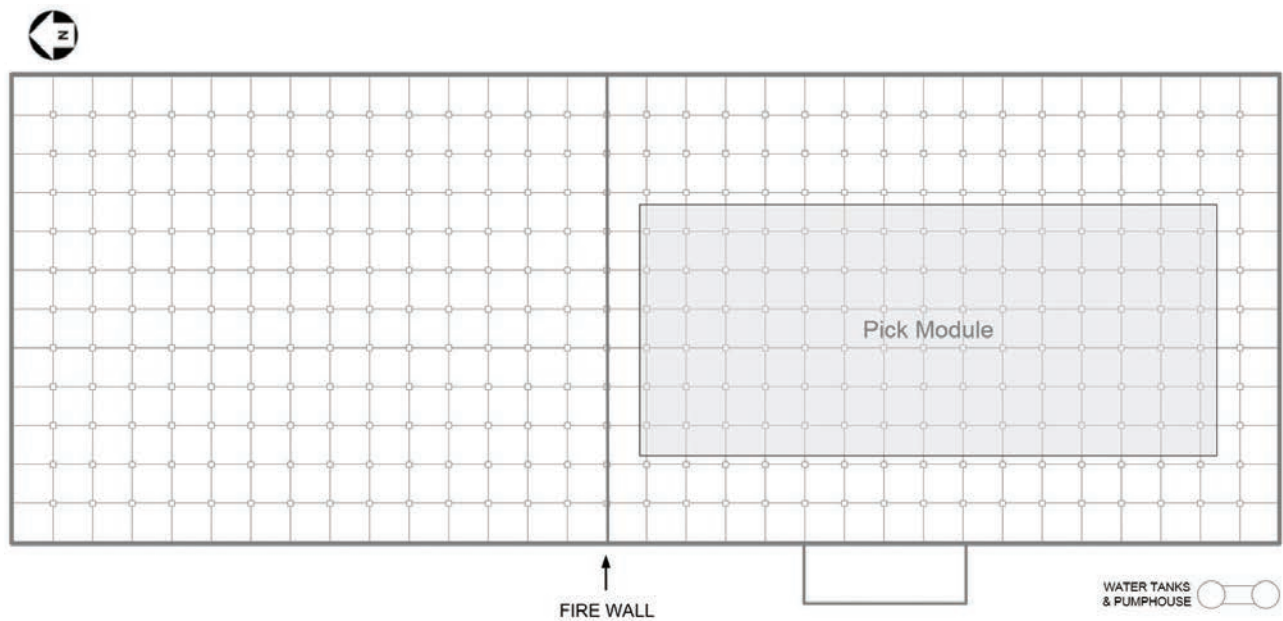
**Figure 4a:** The Pick Module occupied most of the section of the building south of the fire wall.

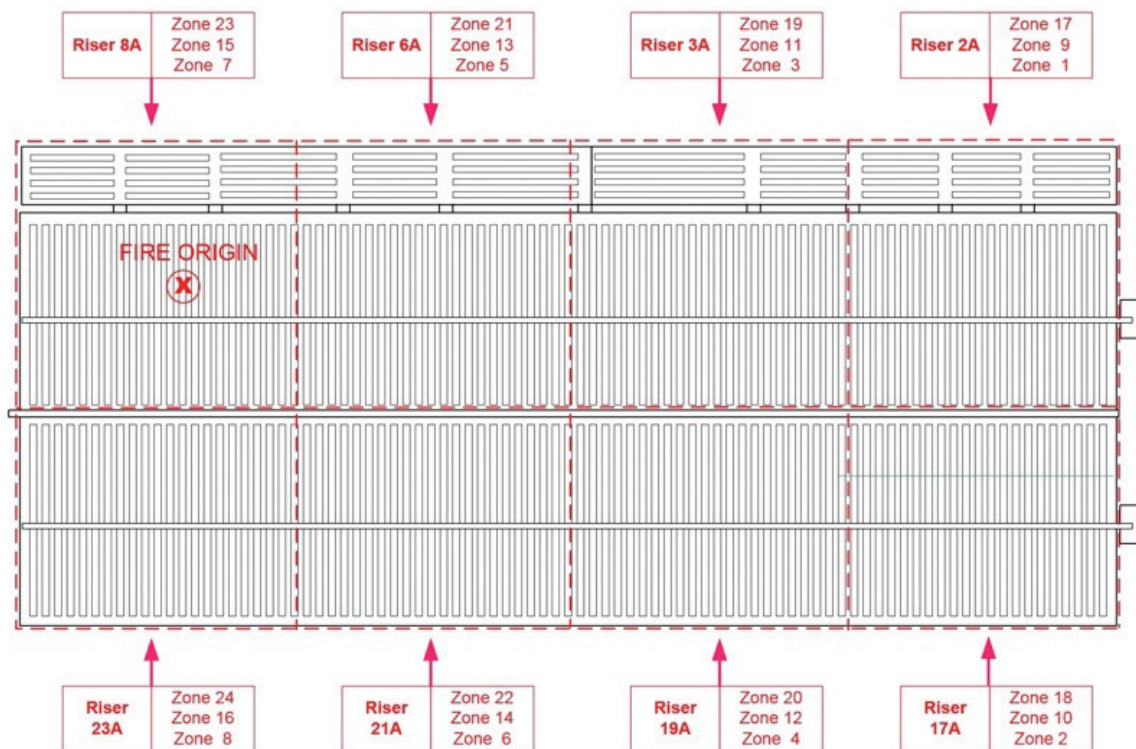
**Figure 13:** The Pick Module was protected by eight CMDA sprinkler systems. Each system was divided into three zones to cover the three lower levels of the structure.

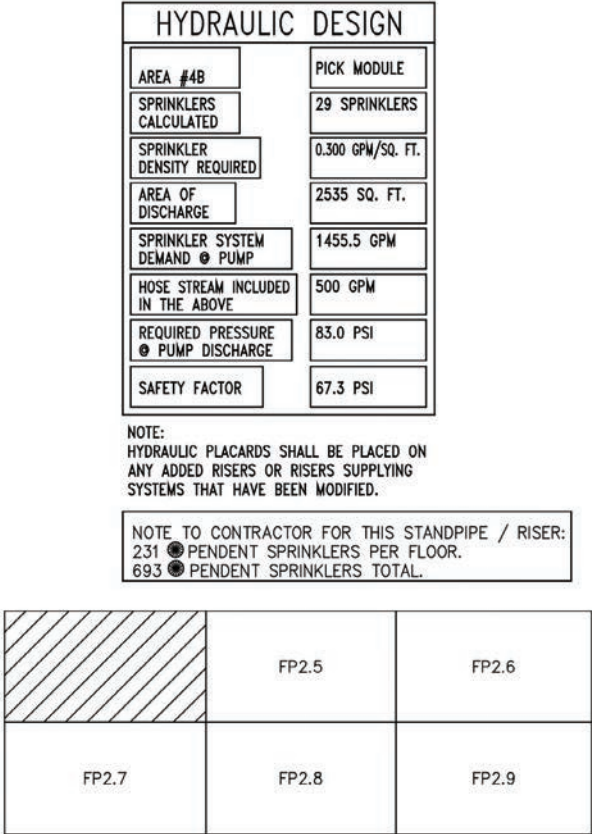
**Figure 14:** The three lower levels of the Pick Module were protected by CMDA (control mode) sprinklers. The top level was covered by the ESFR sprinklers that were installed when the building was constructed.

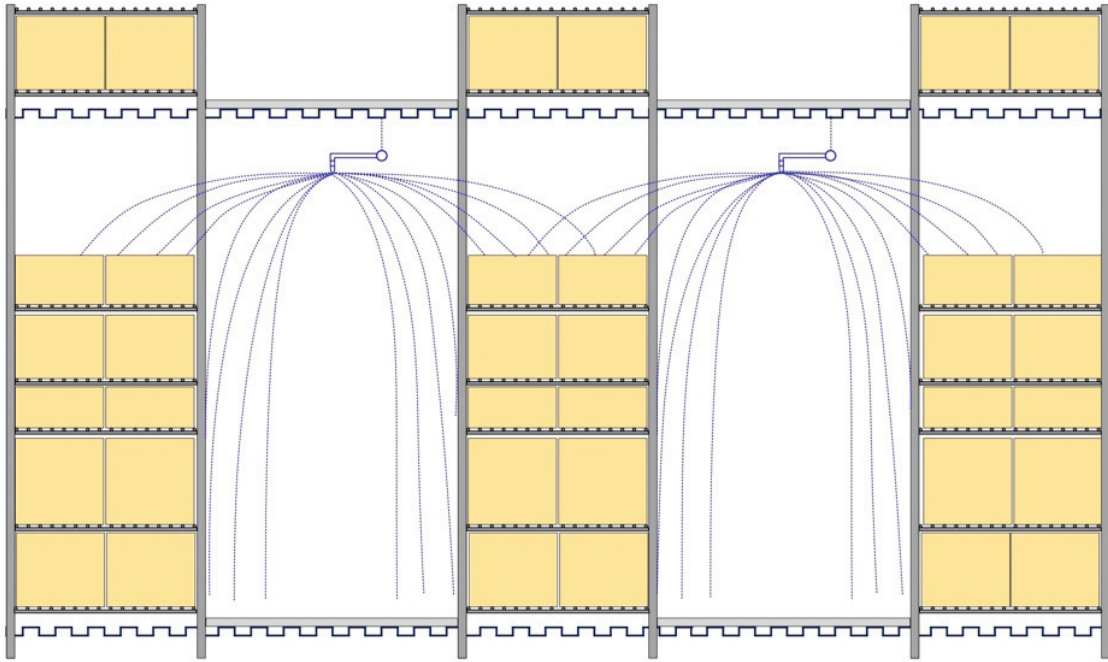
The discharge pattern from the pendant sprinklers was directed downward onto the stored merchandise. They did not direct any discharge upward against the underside of the steel mezzanine decking or to cover any of the openings in the decking.

The shelves were constructed of open steel grating to allow water from the sprinklers to flow down to reach the goods that were stored on the lower shelves; however, the tight packing of goods on the shelves would tend to limit the amount of water that could reach the lower levels.

**Figure 15:** The Pick Module sprinklers were positioned to discharge water onto the top level of the stored goods and to cover the vertical faces on each side of the aisles.

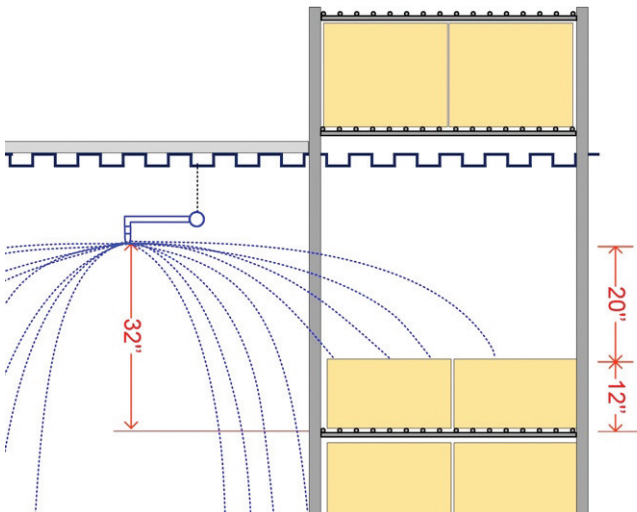
The sprinkler plans indicate that the deflectors of the pendant heads were positioned 32" above the top shelves. The maximum height limit of 12" for boxes stored on the top shelves provided for a minimum clearance of 20" to avoid obstruction of the sprinkler discharge pattern. In storage areas it is always important to ensure that there are no tall items encroaching on the required space and blocking the sprinkler distribution pattern.

**Figure 16:** The 12" height limitation for goods placed on the top shelves was required to provide 20" of unobstructed space for the sprinkler discharge pattern.

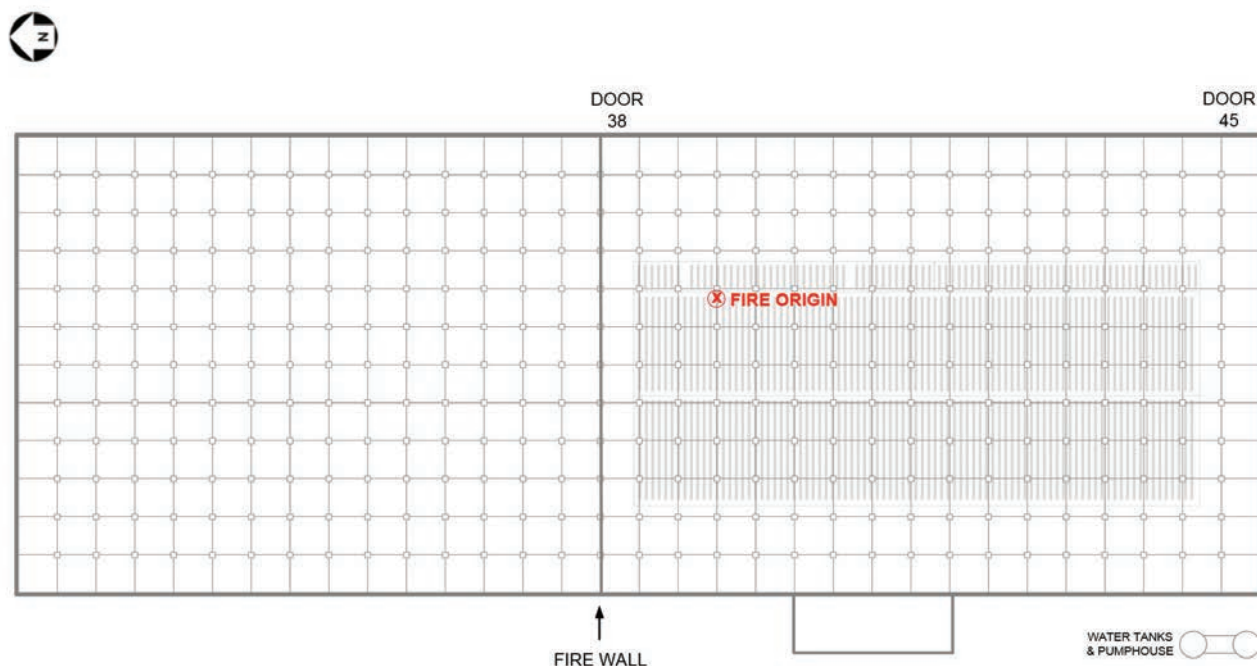
**Figure 17:** Responding units were originally directed to door 45 and were redirected by employees to enter through door 38. This door was approximately 350 feet from the fire area on the 2nd level of the Pick Module; however, the direct path was obstructed by stored goods and a complex system of conveyors.

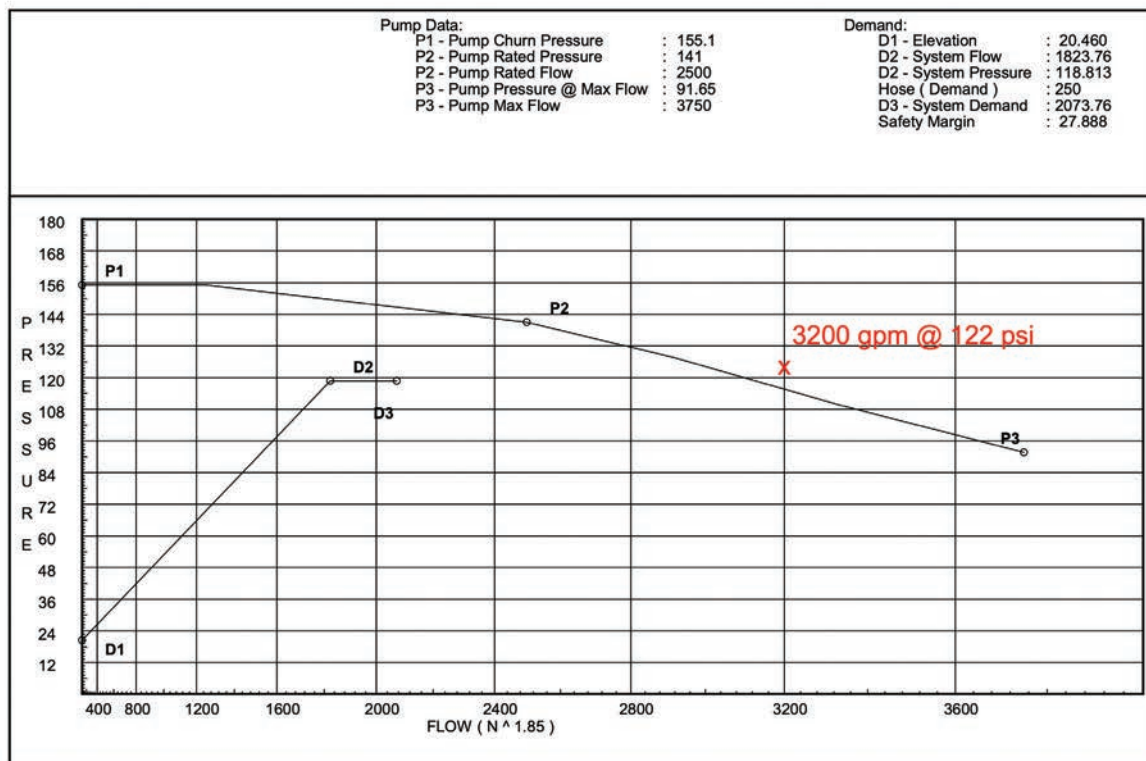
**Figure 17.** The water supply curve that was derived from a pump test after the fire indicates that the combined design flows from the ESFR and Pick Module sprinklers probably would have exceeded the available supply with one fire pump in operation.
